Inspection Report

Property Address:
123 Your Street
Las Vegas NV 00000

Spectrum Inspection Group Inc.

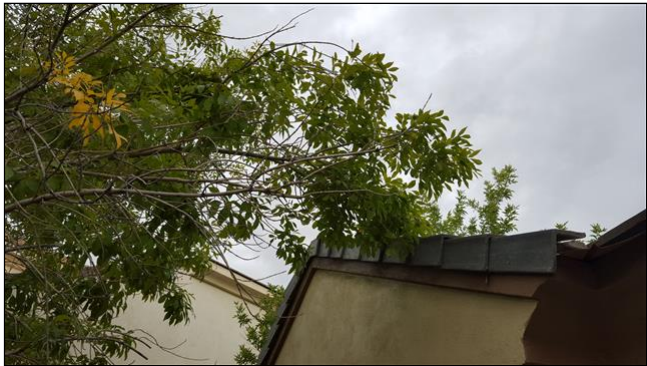
3.2 Item 1(Picture)

(1) Tree branches are in contact with the roof covers and structure. This condition can cause damage to roof covers and structure especially in periods of windy weather. All tree limbs in contact with structure or over hanging roof covers should be removed.

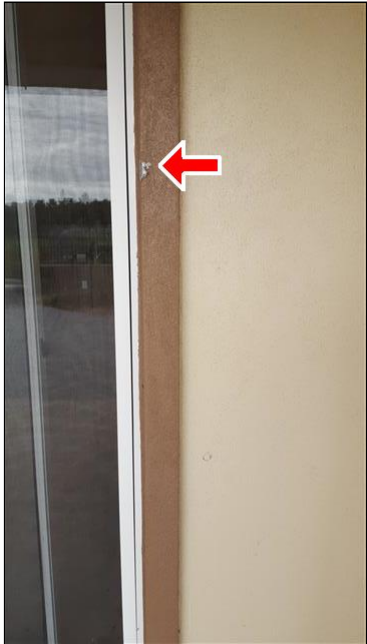
3.7 Item 1(Picture) rear

(2) Areas of stucco recommended for repair and maintenance include areas of damage primarily at the rear. Recommend repair to match existing finish of all areas of damage and cracks exceeding 1/16 th of an inch by a qualified professional to prevent water intrusion.

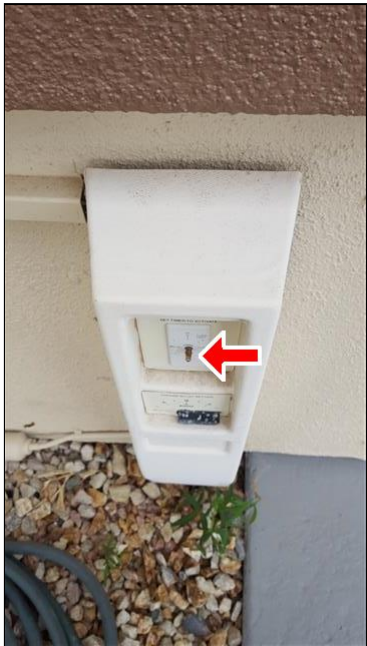
3.11 Item 1(Picture)

The patio mist pump is missing a handle and the system was not properly operational. Recommend evaluation and repair by a qualified professional.

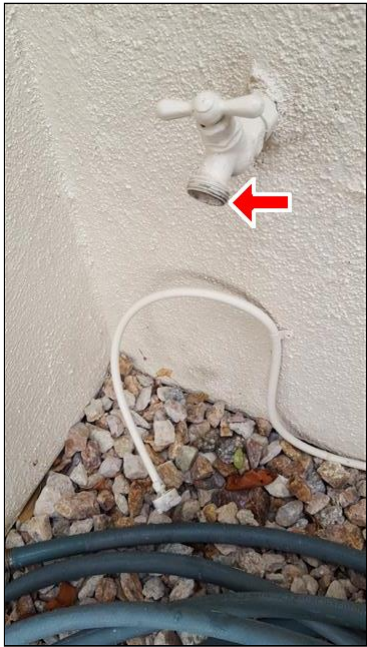
5.4 Item 1(Picture) rear

The hose bib at the rear is drip leaking when turned off. Recommend repair or replacement by a plumbing professional.

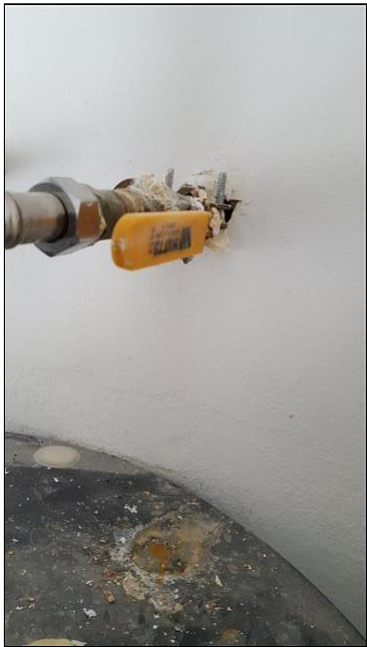
5.7 Item 3(Picture)

(2) Corrosion is present at the water heater plumbing. No leaking was observed at the time of inspection, however corrosion can be indicative of slow leaking and can lead to sudden failure in the future. Recommend proactive repair of corroded plumbing and valves by a plumbing professional, or careful monitoring.

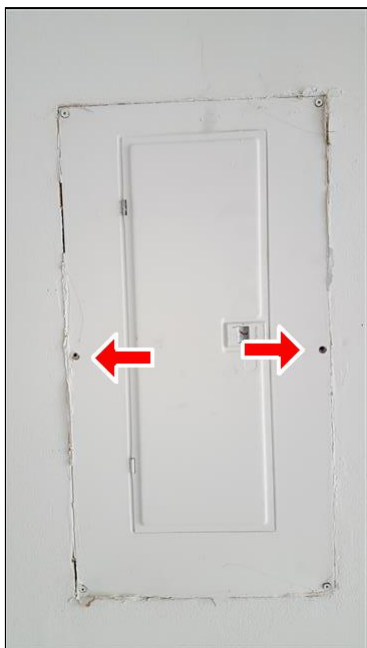
6.3 Item 3(Picture)

(2) Two panel cover screw(s) are missing. Loose panel covers can be an increased fire hazard. Each screw hole should have installed in it a special, blunt-end screw made especially for this purpose.

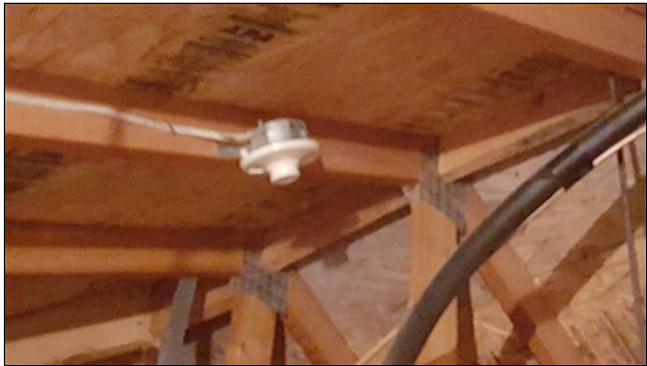
6.6 Item 1(Picture) Attic

Lighting inoperative. It is thought the inoperative lighting may be the result of burned out bulbs but it is strongly recommended all bulbs be replaced and all lighting be verified to operate at the final walk through inspection to ensure a more serious condition does not exist.

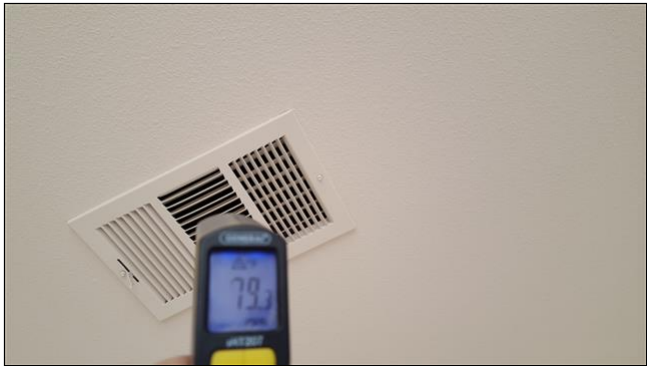
7.5 Item 3(Picture) Upstairs supply

(2) An air temperature differential test was performed on the upstairs main house unit to determine if the difference in temperatures of the supply and return air are between 16 degrees F and 23 degrees F, which indicates that the unit is cooling as intended. The supply air temperature on the upstairs system read (79 degrees F), and the return air temperature was (77 degrees F). This indicates that the upstairs unit's range in temperature drop is less than normal. Recommend evaluation and repair by an HVAC professional.

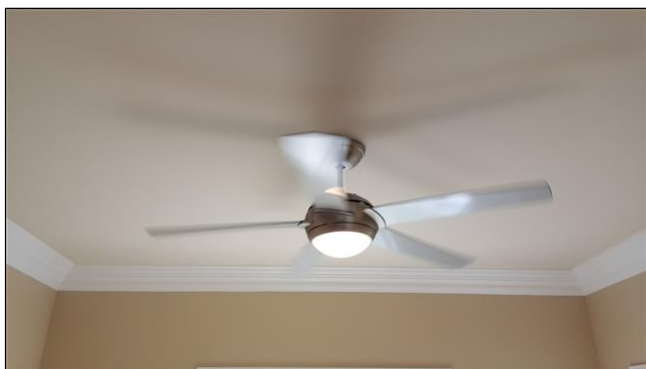
7.6 Item 1(Picture) upstairs family room

(1) A ceiling fan in the second floor family room is noisy and not properly operable. Recommend repair or replacement as necessary by a qualified professional.

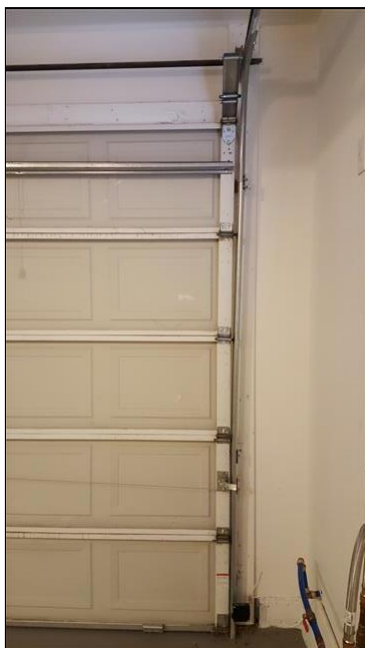
9.2 Item 1(Picture)

(2) The west garage door has minor damage and is not smoothly operable. Recommend maintenance, adjustment, and repair as necessary by a garage door professional to restore proper operability.

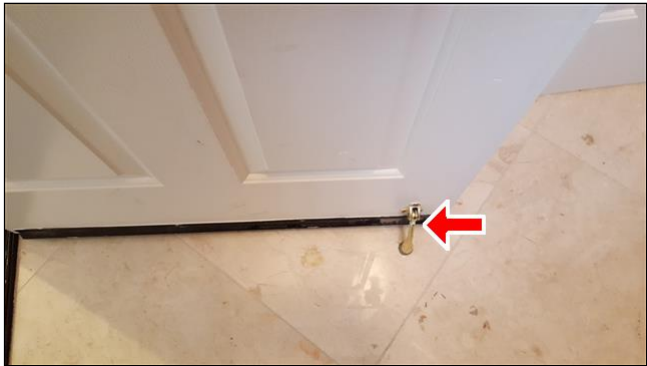
9.3 Item 1(Picture)

(2) Recommend removal of doorstop from fire door to ensure door closes as intended.

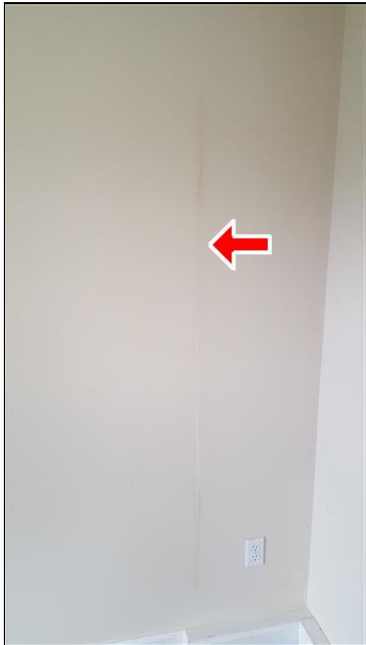
10.3 Item 1(Picture) casita

(1) Cracks are present at the casita walls and ceilings. The areas tested dry by thermal image at the time of inspection. Recommend repair to match existing finish.

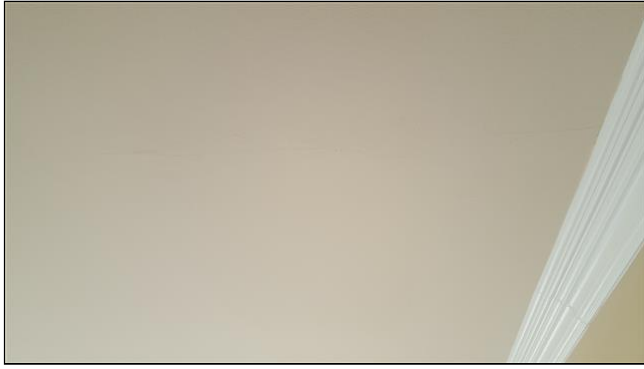
10.3 Item 3(Picture) master bedroom, representative photo

(2) Minor cracks are evident in the walls and/or ceilings, and evidence of possible prior or current water intrusion. Recommend evaluation and repair of roof as detailed in 4.2(2) and continued monitoring and repair if further defects become apparent. Recommend repair to drywall defects to match existing finish as desired.

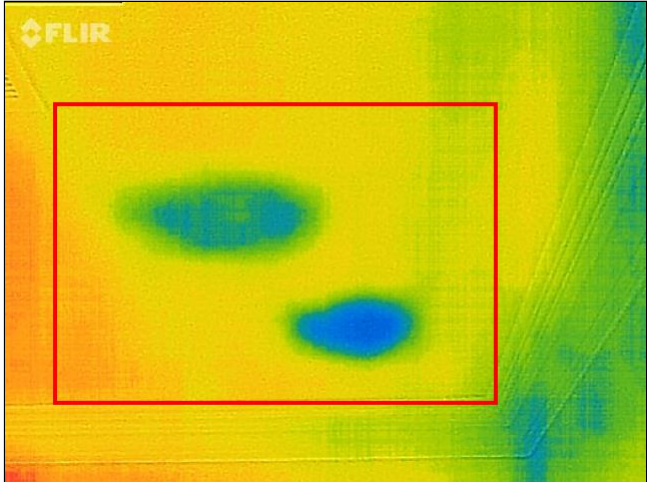
10.3 Item 4(Picture) master ceiling

(3) The master bedroom and upstairs ceilings were evaluated by thermal image in the area of the observed roofing defects. Multiple areas of apparent water intrusion were observed where indicated by thermal image at the east side of master bedroom ceiling and in the attic. Recommend evaluation of the roofing material including the underlayment in the areas noted by a licensed roofing professional and necessary repair to standards. Recommend repair to affected structure and wall finish by a qualified professional.

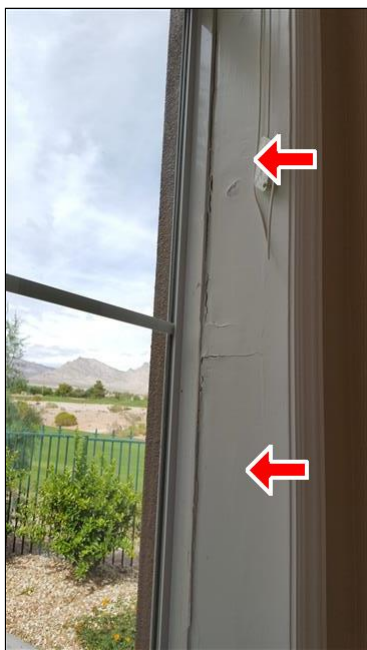
10.5 Item 1(Picture)

(1) Evidence of water intrusion is present around the west facing living room windows. Recommend evaluation and repair to the window seals and flashing as necessary by a window professional, and repair to the affected structure by a qualified professional.

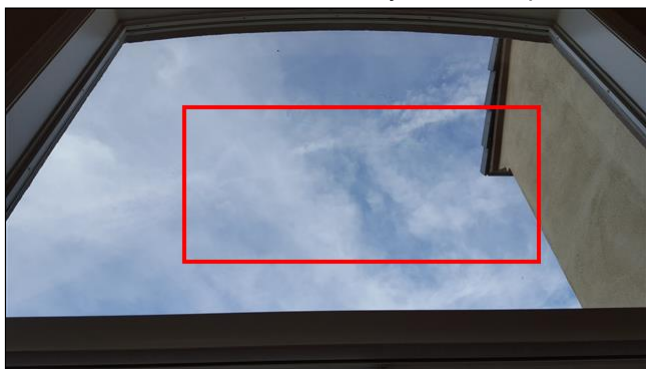
10.5 Item 2(Picture)

(2) The upper window at the north facing living room window has discoloration which could indicate a thermal seal defect. Recommend evaluation by a window professional

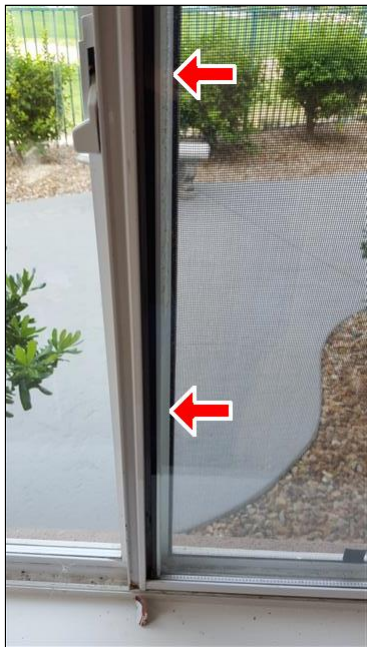
10.5 Item 3(Picture)

(3) The sliding window at the north facing living room window is missing a metal component of the frame which covers the edge of the glass pane. Recommend repair by a window professional to prevent loosening of the glass pane.

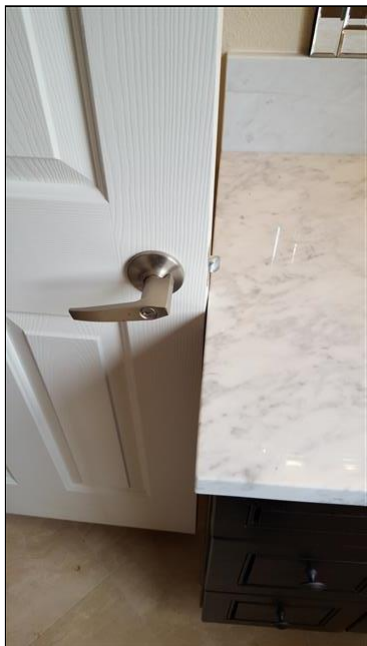
10.6 Item 1(Picture) Casita
bathroom**11. Kitchen****11.4 KITCHEN ELECTRICAL****Inspected, Repair / Replace**

The door at the casita bathroom contacts the vanity top during operation.

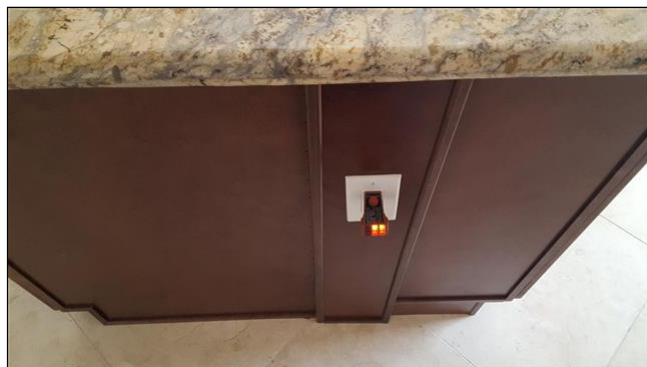
11.4 Item 1(Picture) island

The kitchen outlets at the island are not GFCI protected as required. Since the kitchen has been remodeled, all counter top outlets should be upgraded to GFCI protection according to current standards. Recommend installation of GFCI protection at the island and kitchen countertop outlets by an electrical professional.

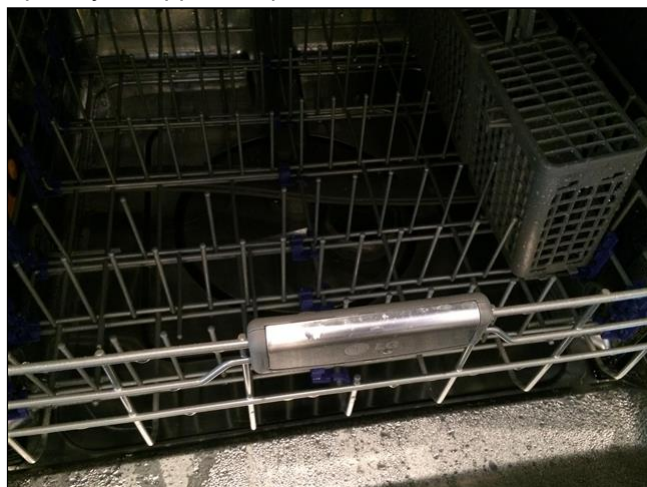
11.7 Item 1(Picture)

The dishwasher was observed to have water inside at the end of its cycle. Recommend evaluation and necessary repair by an appliance professional.

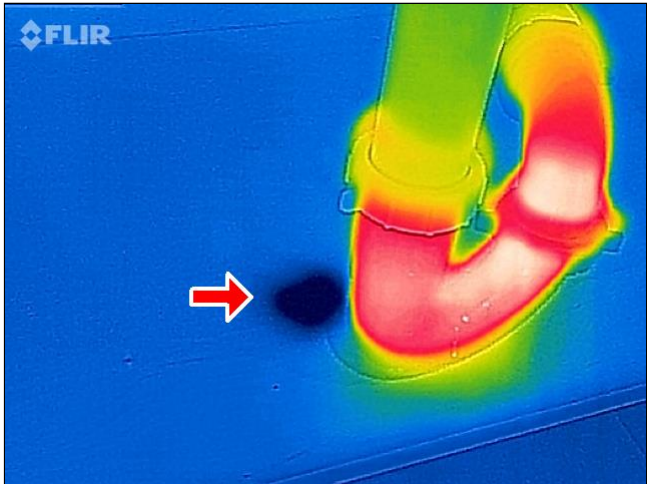
12.1 Item 2(Picture)

(2) The sinks at the master bathroom are leaking around the drain. Recommend repair by plumbing professional.

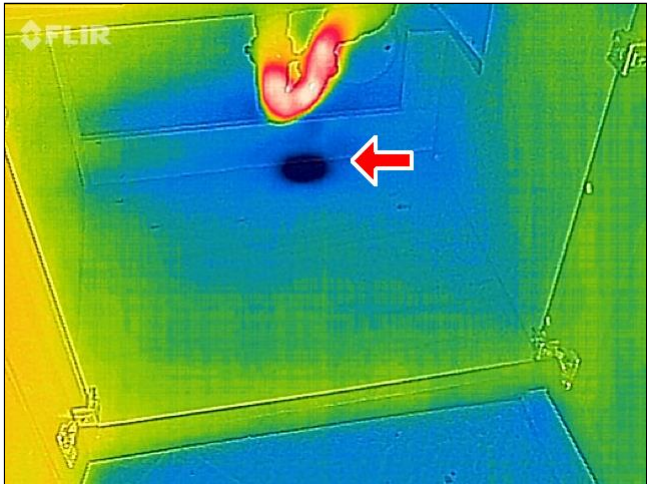
12.1 Item 7(Picture)

(3) Water is present at the casita sink where indicate from an apparent leak. Recommend evaluation and repair by a plumbing professional.

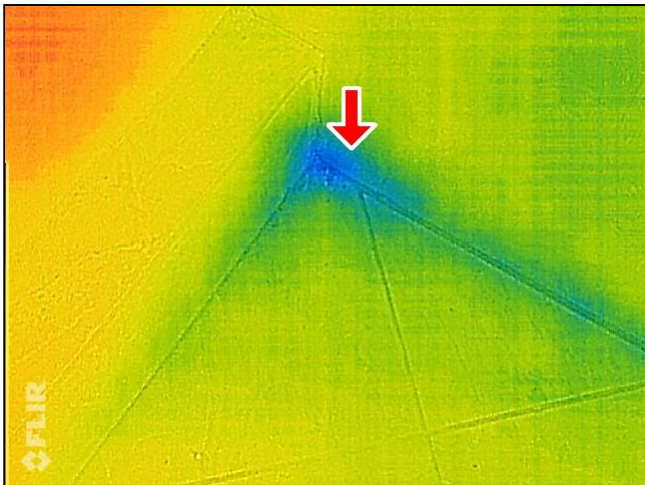
12.4 Item 4(Picture)

(1) Cracked grout at the casita shower is present. The shower accumulates water at the far end. After operating the shower, evidence of water intrusion is evident by thermal image outside the shower in the corner at the exterior bathroom wall. Recommend evaluation and necessary repair by a tile professional.

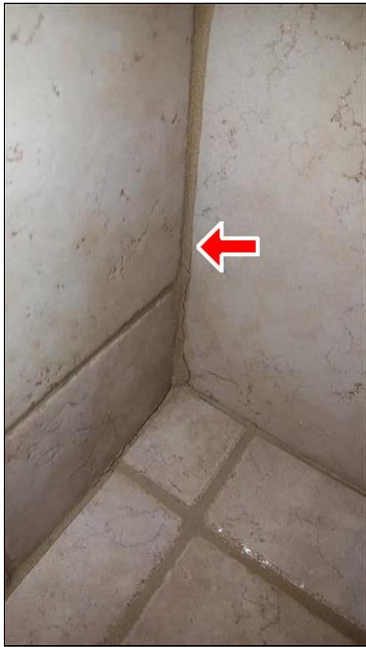
12.4 Item 5(Picture) master bathroom shower

(2) Grout at the master bathroom shower is deteriorated. Missing or deteriorated caulking and grout can promote water penetration into the adjoining structure. The old caulking and any loose grout should be removed and the openings resealed and regouted.

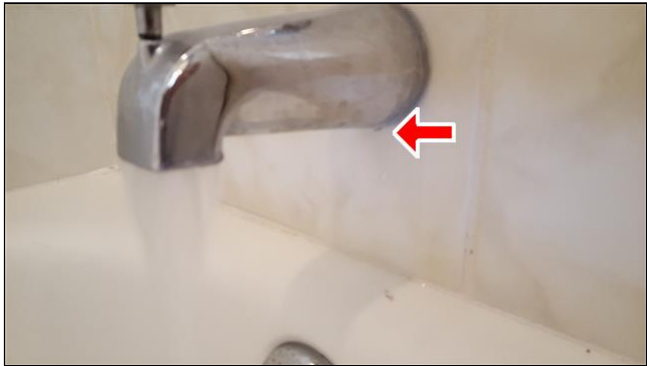
12.5 Item 1(Picture) upstairs guest bathroom

The tub/shower faucet at the upstairs guest bathroom leaks water at the wall and has a shower diverter not properly operable. After operating the faucet, evidence of water intrusion is present at the guest bedroom wall opposite the bathroom which indicates the faucet could be leaking water into the wall. Recommend evaluation and repair or replacement of the faucet by a plumbing professional. Since the possibility of persistent water intrusion into structure is present, we recommend a mold inspection by a licensed mold inspection company.

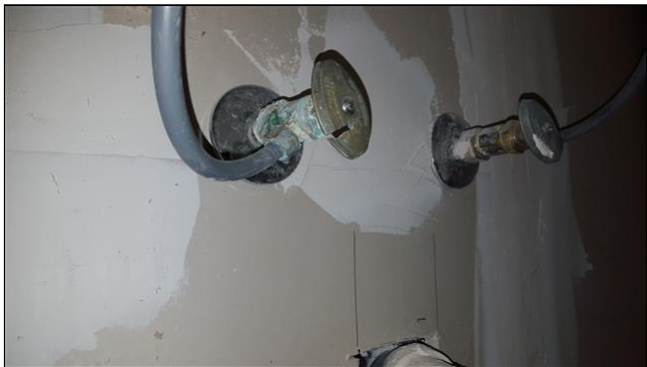
13.7 Item 1(Picture)

Corrosion is present at the laundry faucet supply valves. No leaking was observed at the time of inspection, however corrosion can be indicative of slow leaking and can lead to sudden failure in the future. Recommend proactive repair of corroded plumbing and valves by a plumbing professional, or careful monitoring.

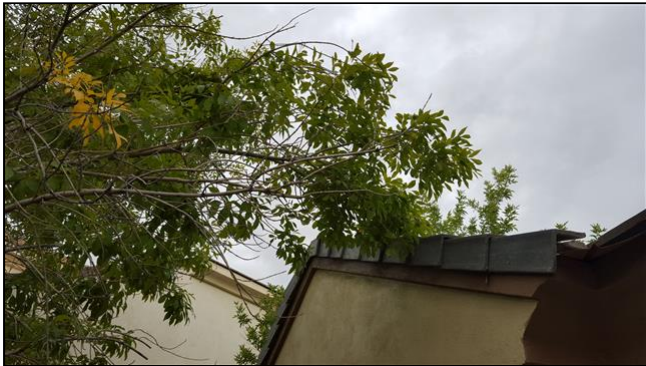
3.2 Item 1(Picture)

(1) Tree branches are in contact with the roof covers and structure. This condition can cause damage to roof covers and structure especially in periods of windy weather. All tree limbs in contact with structure or over hanging roof covers should be removed.

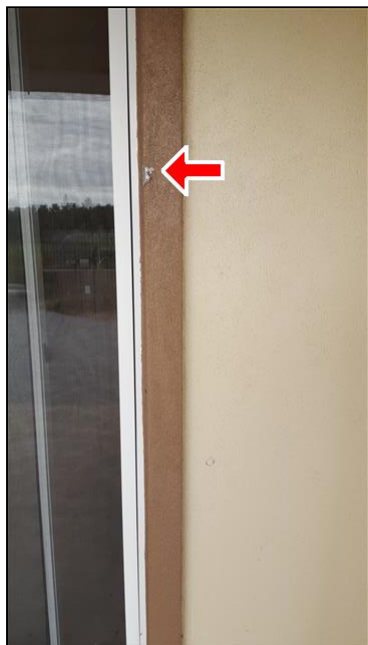
3.7 Item 1(Picture) rear

(2) Areas of stucco recommended for repair and maintenance include areas of damage primarily at the rear. Recommend repair to match existing finish of all areas of damage and cracks exceeding 1/16 th of an inch by a qualified professional to prevent water intrusion.

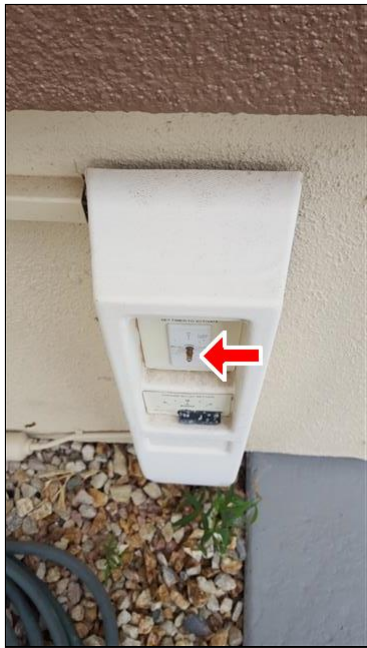
3.11 Item 1(Picture)

The patio mist pump is missing a handle and the system was not properly operational. Recommend evaluation and repair by a qualified professional.

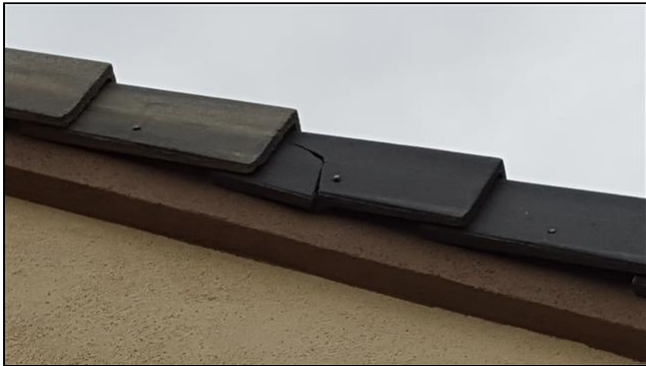
4.2 Item 1(Picture) rear

(2) Areas of tile recommend for repair include an area of broken and cracked tile with underlayment exposed primarily at the the east side, at least one broken tile at the front, and a broken edge tile at the rear. Recommend repair of all broken and dislocated tile according to standards by a roofing professional.

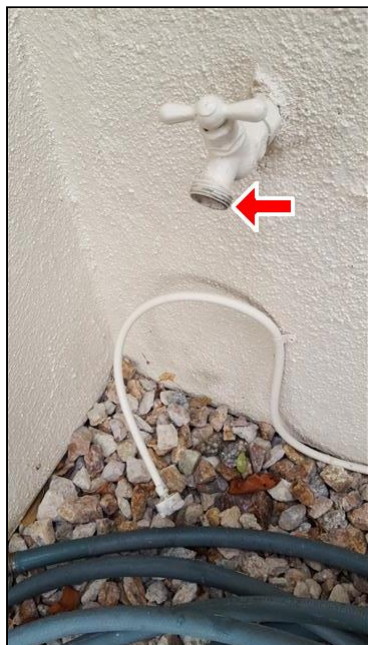
5.4 Item 1(Picture) rear

The hose bib at the rear is drip leaking when turned off. Recommend repair or replacement by a plumbing professional.

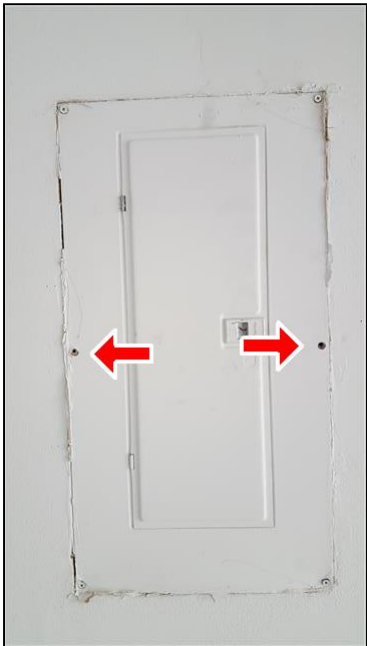
6.3 Item 3(Picture)

(2) Two panel cover screw(s) are missing. Loose panel covers can be an increased fire hazard. Each screw hole should have installed in it a special, blunt-end screw made especially for this purpose.

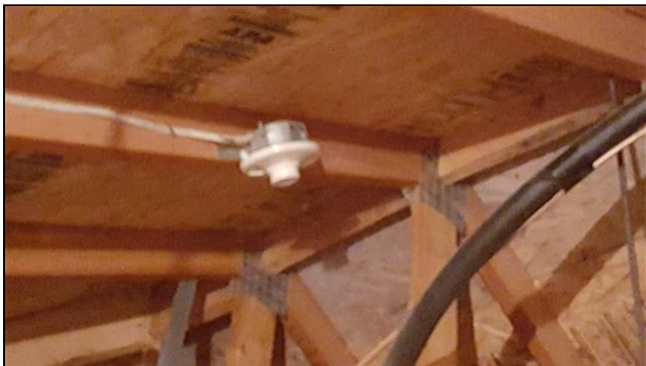
6.6 Item 1(Picture) Attic

Lighting inoperative. It is thought the inoperative lighting may be the result of burned out bulbs but it is strongly recommended all bulbs be replaced and all lighting be verified to operate at the final walk through inspection to ensure a more serious condition does not exist.

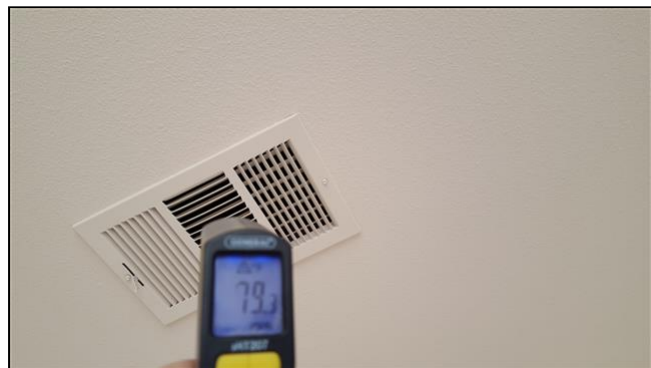
7.5 Item 3(Picture) Upstairs supply

(2) An air temperature differential test was performed on the upstairs main house unit to determine if the difference in temperatures of the supply and return air are between 16 degrees F and 23 degrees F, which indicates that the unit is cooling as intended. The supply air temperature on the upstairs system read (79 degrees F), and the return air temperature was (77 degrees F). This indicates that the upstairs unit's range in temperature drop is less than normal. Recommend evaluation and repair by an HVAC professional.

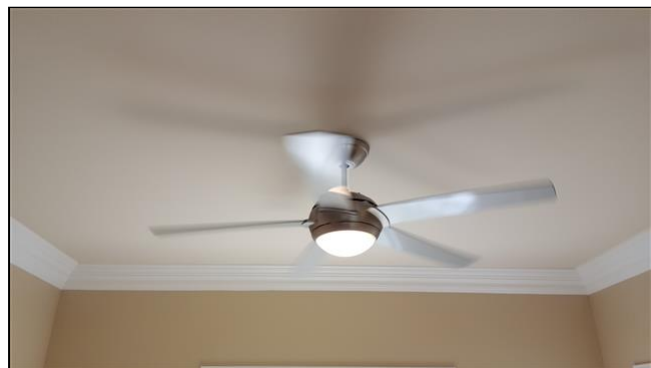
7.6 Item 1(Picture) upstairs family room

(1) A ceiling fan in the second floor family room is noisy and not properly operable. Recommend repair or replacement as necessary by a qualified professional.

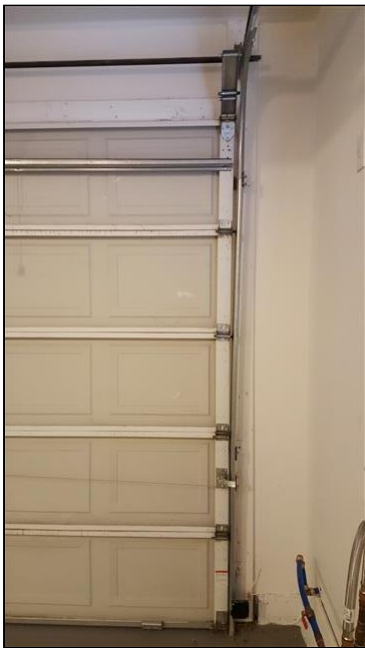
9.2 Item 1(Picture)

- (1) The garage overhead door has a safety pressure/tension reversing mechanism that was tested and found to be operating properly. This feature should be verified periodically in accordance with the garage door opener's homeowners manual. Additionally, this door is equipped with a safety light beam sensors which reverses the door when the light beam gets crossed. This feature was observed to be operating properly. This is deemed to be a positive finding.
- (2) The west garage door has minor damage and is not smoothly operable. Recommend maintenance, adjustment, and repair as necessary by a garage door professional to restore proper operability.

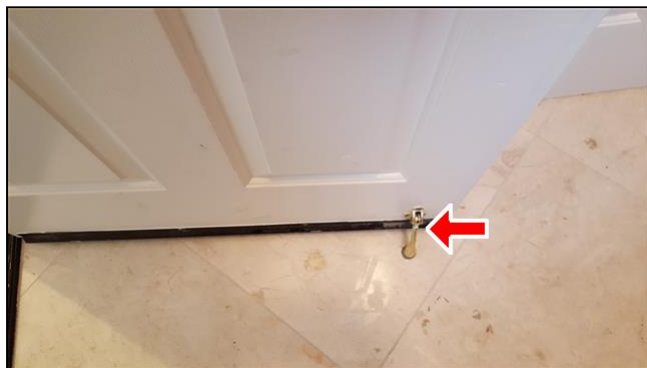
9.3 Item 1(Picture)

- (1) The fire rated assembly was intact with no visible holes and or defects noted on the day of the inspection. The fire door between the house and garage tested positive for self closing function.
- (2) Recommend removal of doorstop from fire door to ensure door closes as intended.

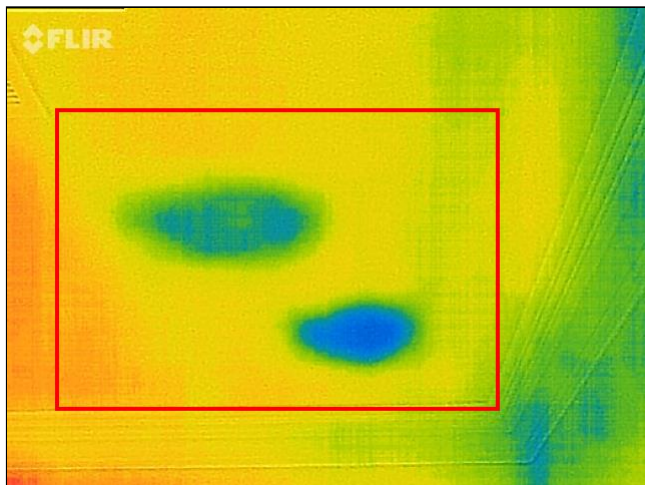
10.3 Item 4(Picture) master ceiling

(3) The master bedroom and upstairs ceilings were evaluated by thermal image in the area of the observed roofing defects. Multiple areas of apparent water intrusion were observed where indicated by thermal image at the east side of master bedroom ceiling and in the attic. Recommend evaluation of the roofing material including the underlayment in the areas noted by a licensed roofing professional and necessary repair to standards. Recommend repair to affected structure and wall finish by a qualified professional.

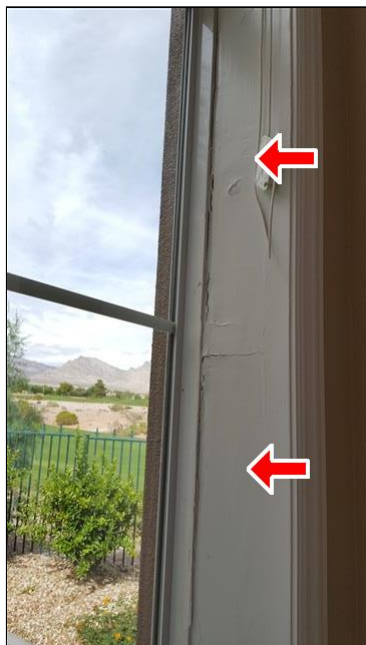
10.5 Item 1(Picture)

(1) Evidence of water intrusion is present around the west facing living room windows. Recommend evaluation and repair to the window seals and flashing as necessary by a window professional, and repair to the affected structure by a qualified professional.

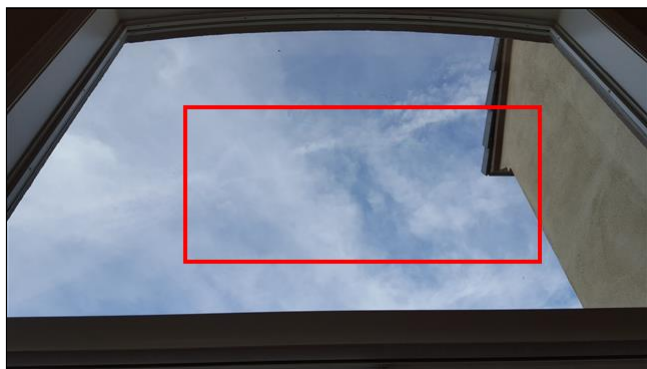
10.5 Item 2(Picture)

(2) The upper window at the north facing living room window has discoloration which could indicate a thermal seal defect. Recommend evaluation by a window professional

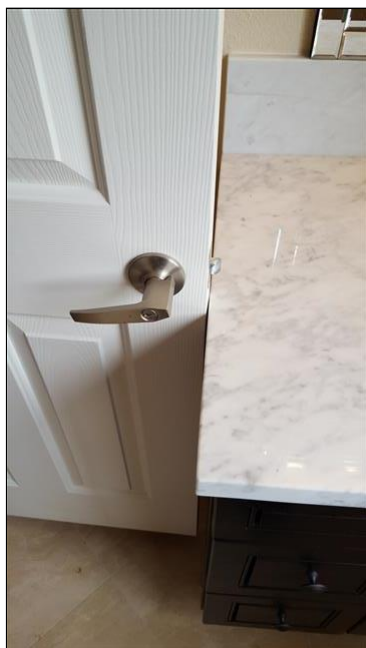
10.6 Item 1(Picture) Casita
bathroom

The door at the casita bathroom contacts the vanity top during operation.

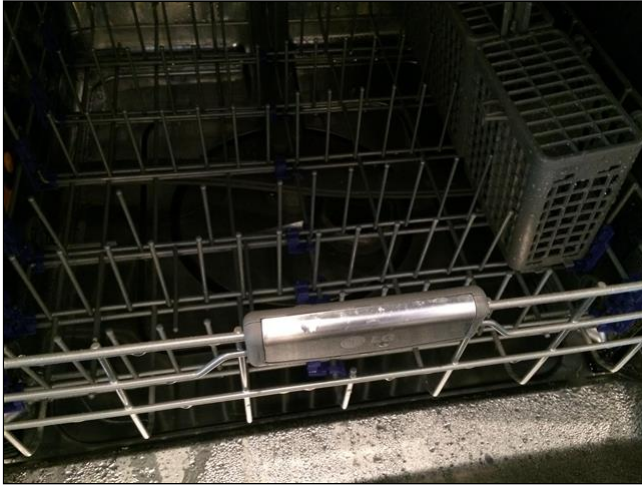
11.7 Item 1(Picture)

The dishwasher was observed to have water inside at the end of its cycle. Recommend evaluation and necessary repair by an appliance professional.

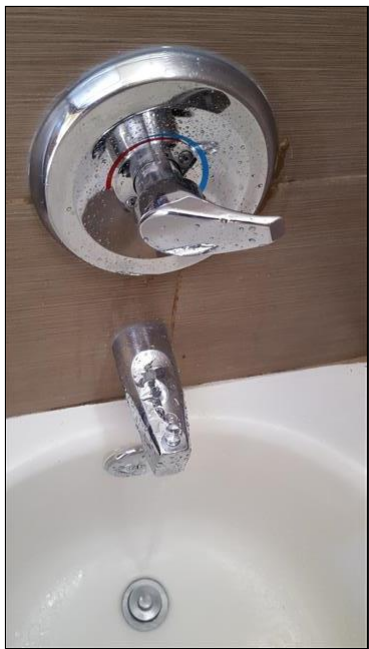
12.1 Item 1(Picture)
downstairs guest bathroom

(1) The tub/shower faucet at the downstairs guest bathroom has abnormally low cold water supply. Possible causes include, but not limited to, the faucet itself, supply valves and lines, or associated plumbing. Recommend evaluation and repair by a plumbing professional.

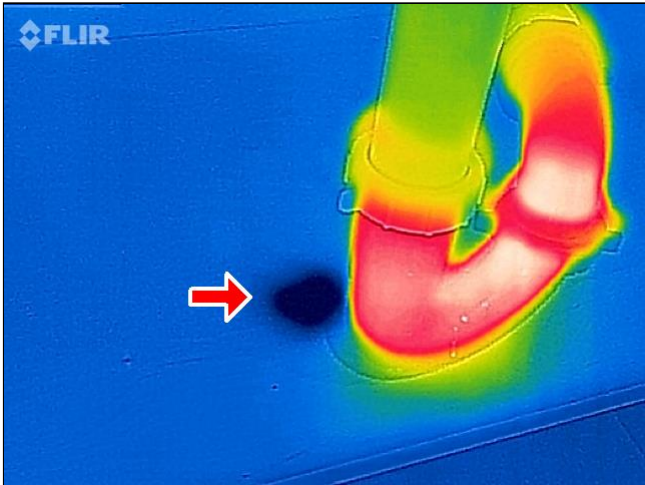
12.1 Item 2(Picture)

(2) The sinks at the master bathroom are leaking around the drain. Recommend repair by plumbing professional.

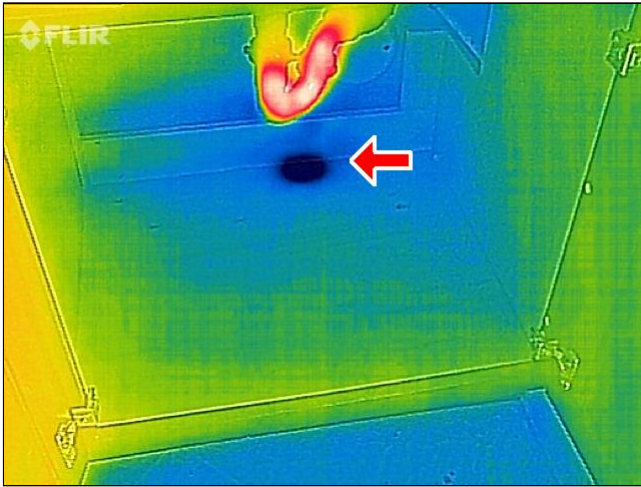
12.1 Item 7(Picture)

(3) Water is present at the casita sink where indicate from an apparent leak. Recommend evaluation and repair by a plumbing professional.

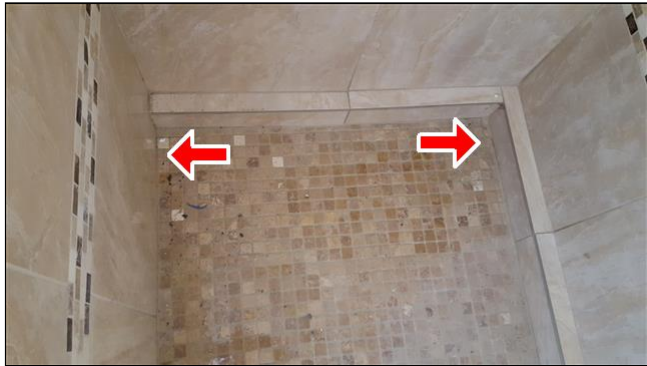
12.4 Item 1(Picture)

(1) Cracked grout at the casita shower is present. The shower accumulates water at the far end. After operating the shower, evidence of water intrusion is evident by thermal image outside the shower in the corner at the exterior bathroom wall. Recommend evaluation and necessary repair by a tile professional.

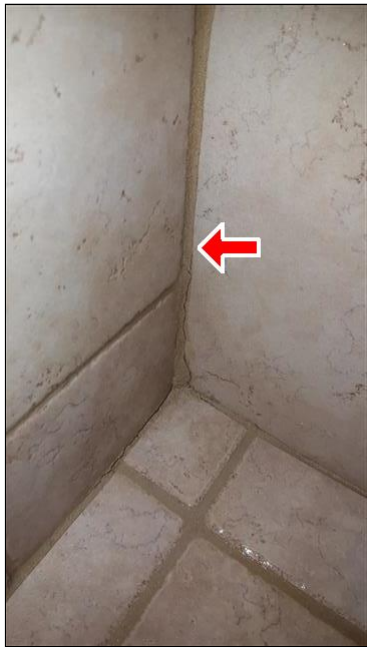
12.4 Item 5(Picture) master bathroom shower

(2) Grout at the master bathroom shower is deteriorated. Missing or deteriorated caulking and grout can promote water penetration into the adjoining structure. The old caulking and any loose grout should be removed and the openings resealed and regouted.

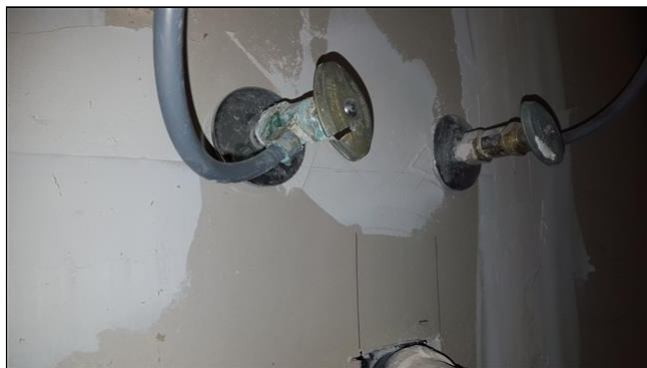
13.7 Item 1(Picture)

Corrosion is present at the laundry faucet supply valves. No leaking was observed at the time of inspection, however corrosion can be indicative of slow leaking and can lead to sudden failure in the future. Recommend proactive repair of corroded plumbing and valves by a plumbing professional, or careful monitoring.
