Inspection Report

Property Address:
123 Your Street
Las Vegas NV 00000

Spectrum Inspection Group Inc.

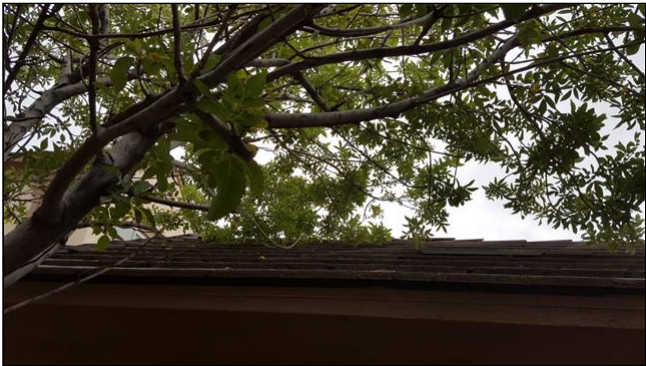
3.2 Item 1(Picture)

(1) Tree branches are in contact with the roof covers and structure. This condition can cause damage to roof covers and structure especially in periods of windy weather. All tree limbs in contact with structure or over hanging roof covers should be removed.

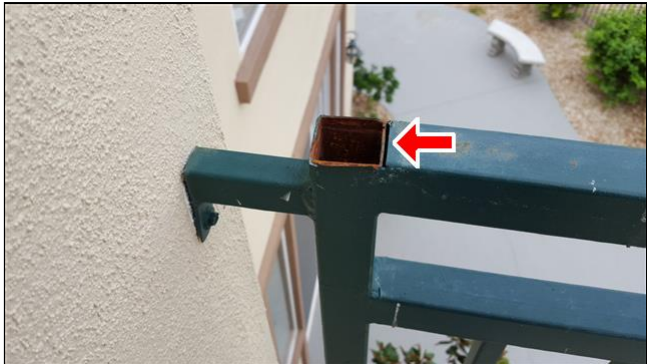
3.4 Item 1(Picture)

(2) The balcony railing is missing post caps which can expose sharp edges which can be a hazard. Recommend replacement of missing caps by a qualified professional.

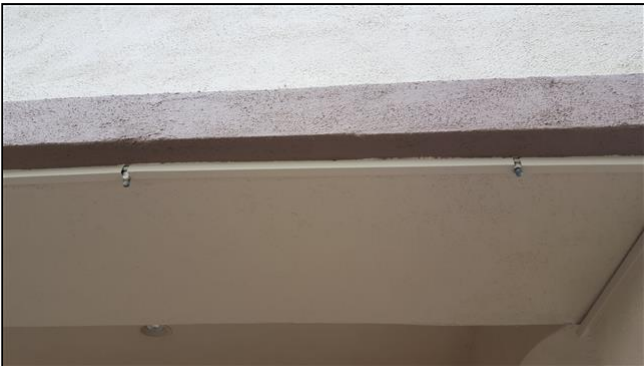
3.11 Item 2(Picture)

The patio mist pump is missing a handle and the system was not properly operational. Recommend evaluation and repair by a qualified professional.

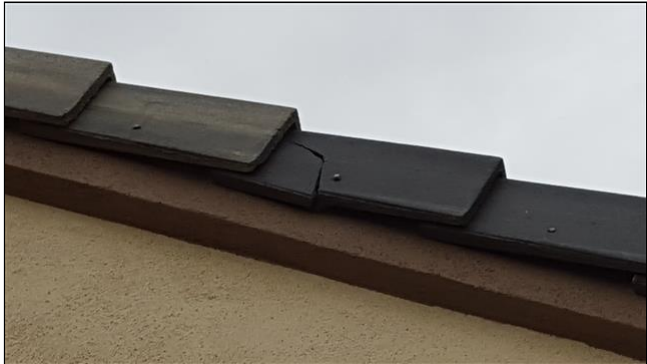
(2) Areas of tile recommend for repair include an area of broken and cracked tile with underlayment exposed primarily at the the east side, at least one broken tile at the front, and a broken edge tile at the rear. Recommend repair of all broken and dislocated tile according to standards by a roofing professional.

4.2 Item 1(Picture) rear

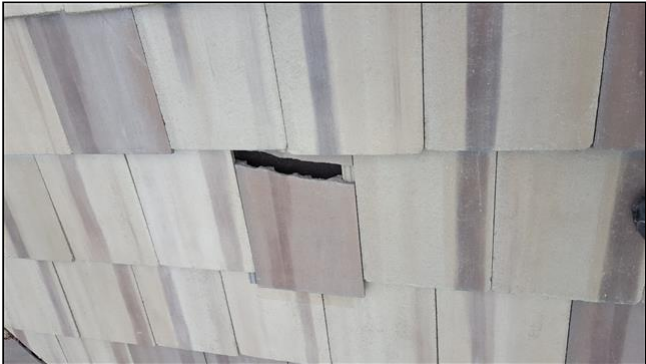
4.2 Item 2(Picture) front

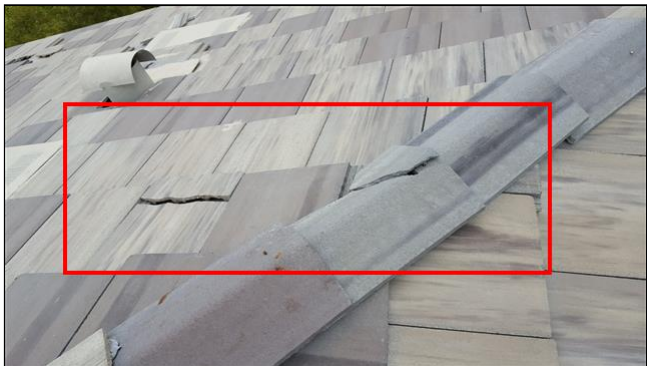
4.2 Item 3(Picture) east

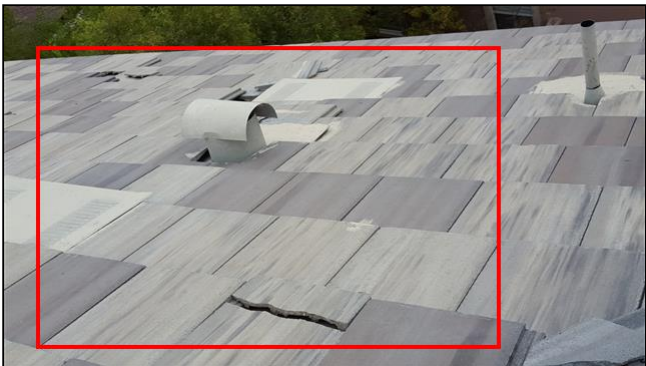
4.2 Item 4(Picture) east

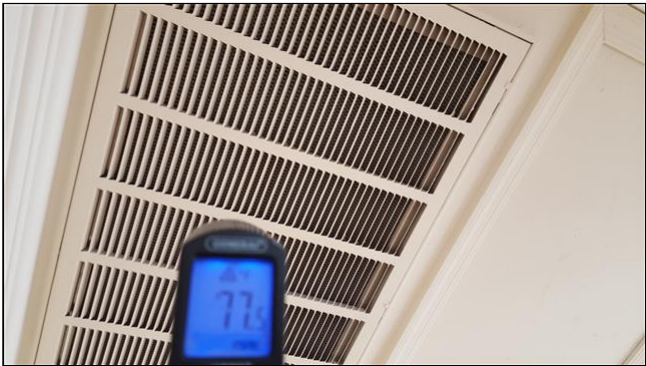
(2) An air temperature differential test was performed on the upstairs main house unit to determine if the difference in temperatures of the supply and return air are between 16 degrees F and 23 degrees F, which indicates that the unit is cooling as intended. The supply air temperature on the upstairs system read (79 degrees F), and the return air temperature was (77 degrees F). This indicates that the upstairs unit's range in temperature drop is less than normal. Recommend evaluation and repair by an HVAC professional.

7.5 Item 4(Picture) Upstairs return

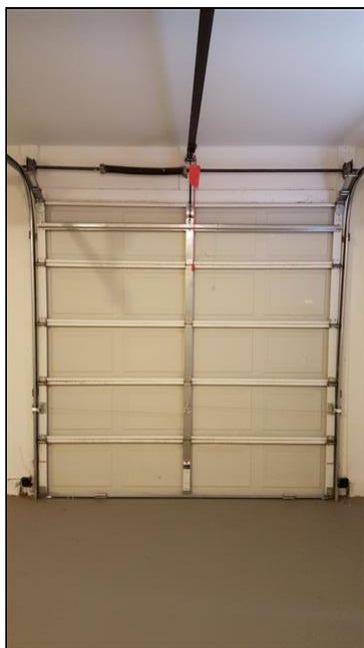
9.2 Item 2(Picture)

(2) The west garage door has minor damage and is not smoothly operable. Recommend maintenance, adjustment, and repair as necessary by a garage door professional to restore proper operability.

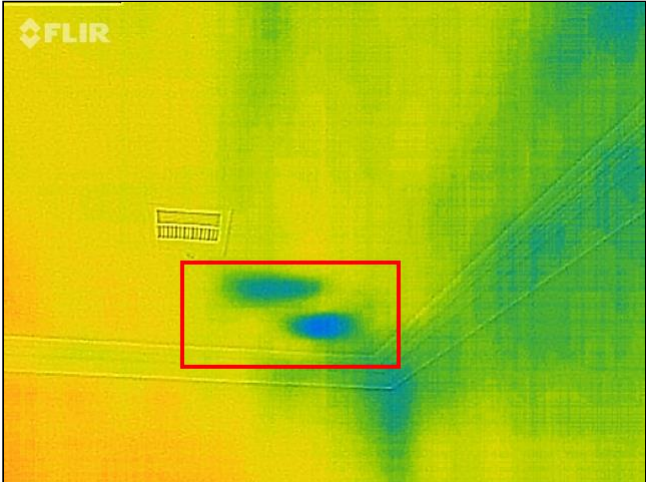
(3) The master bedroom and upstairs ceilings were evaluated by thermal image in the area of the observed roofing defects. Multiple areas of apparent water intrusion were observed where indicated by thermal image at the east side of master bedroom ceiling and in the attic. Recommend evaluation of the roofing material including the underlayment in the areas noted by a licensed roofing professional and necessary repair to standards. Recommend repair to affected structure and wall finish by a qualified professional.

10.3 Item 5(Picture) master ceiling

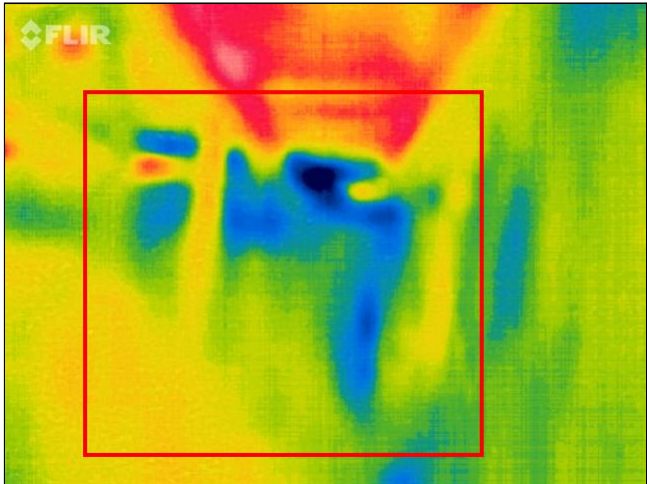
10.3 Item 6(Picture) attic

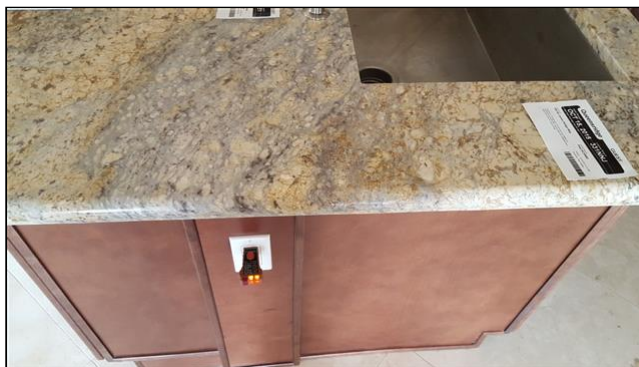
The kitchen outlets at the island are not GFCI protected as required. Since the kitchen has been remodeled, all counter top outlets should be upgraded to GFCI protection according to current standards. Recommend installation of GFCI protection at the island and kitchen countertop outlets by an electrical professional.

11.4 Item 2(Picture) island

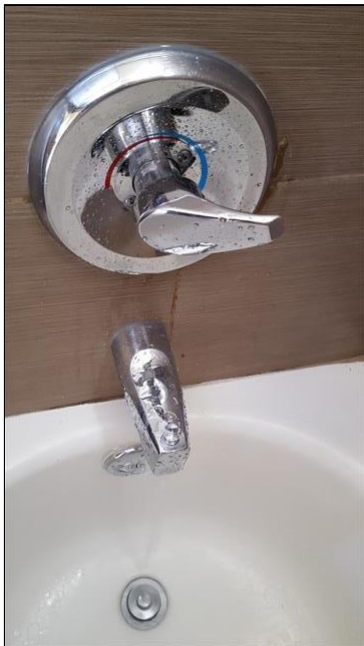
(1) The tub/shower faucet at the downstairs guest bathroom has abnormally low cold water supply. Possible causes include, but not limited to, the faucet itself, supply valves and lines, or associated plumbing. Recommend evaluation and repair by a plumbing professional.

12.1 Item 1(Picture)
downstairs guest bathroom

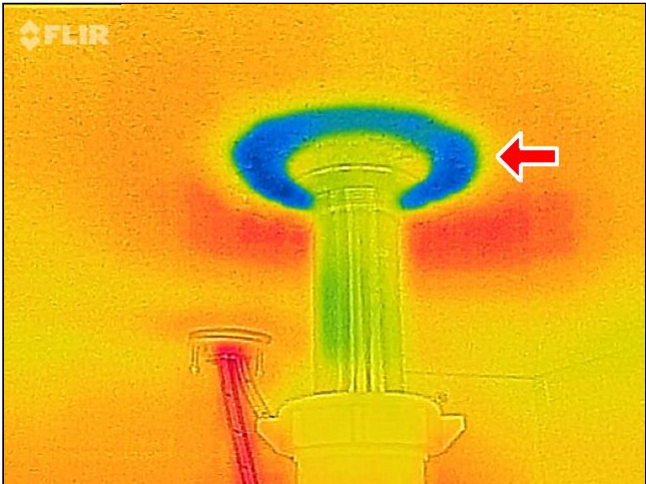
12.1 Item 3(Picture)

(2) The sinks at the master bathroom are leaking around the drain. Recommend repair by plumbing professional.

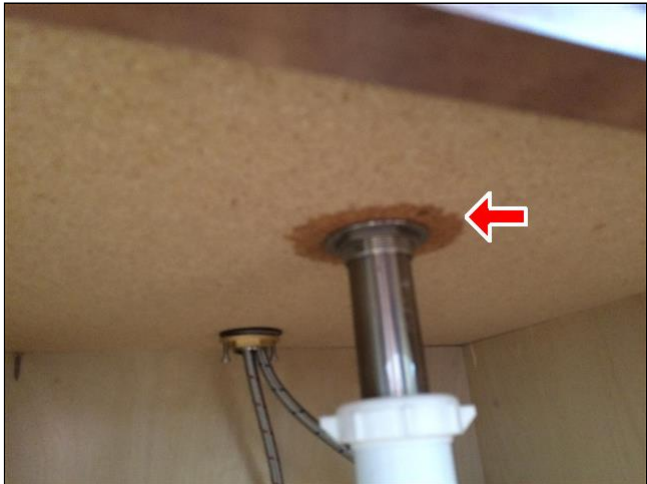
12.1 Item 4(Picture) right master

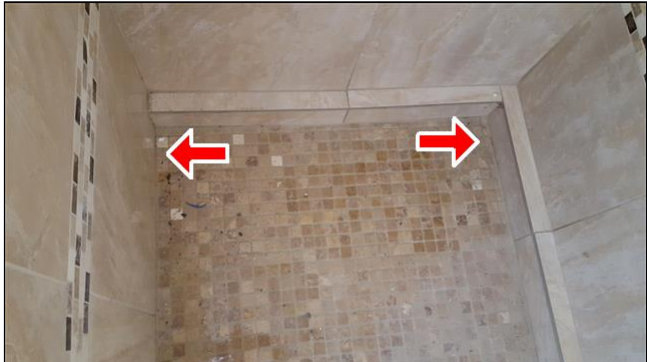
12.4 Item 1(Picture)

(1) Cracked grout at the casita shower is present. The shower accumulates water at the far end. After operating the shower, evidence of water intrusion is evident by thermal image outside the shower in the corner at the exterior bathroom wall. Recommend evaluation and necessary repair by a tile professional.

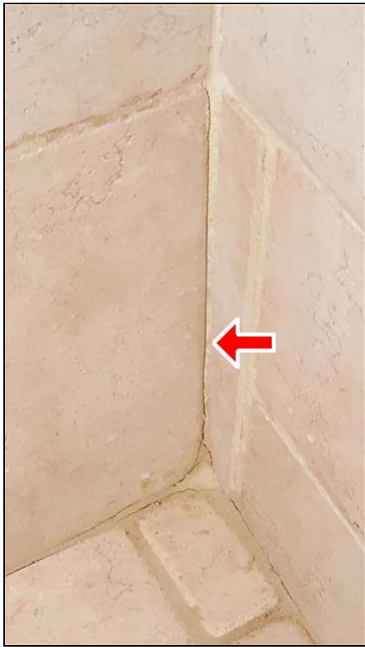
(2) Grout at the master bathroom shower is deteriorated. Missing or deteriorated caulking and grout can promote water penetration into the adjoining structure. The old caulking and any loose grout should be removed and the openings resealed and regouted.

12.4 Item 6(Picture) master bathroom shower

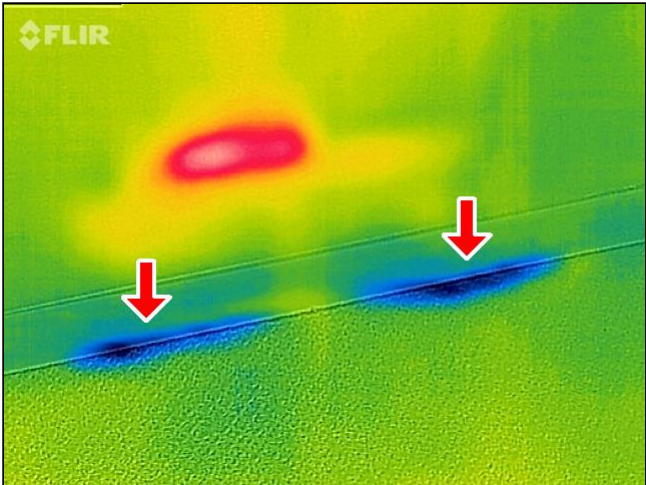
12.5 Item 2(Picture)

The tub/shower faucet at the upstairs guest bathroom leaks water at the wall and has a shower diverter not properly operable. After operating the faucet, evidence of water intrusion is present at the guest bedroom wall opposite the bathroom which indicates the faucet could be leaking water into the wall. Recommend evaluation and repair or replacement of the faucet by a plumbing professional. Since the possibility of persistent water intrusion into structure is present, we recommend a mold inspection by a licensed mold inspection company.

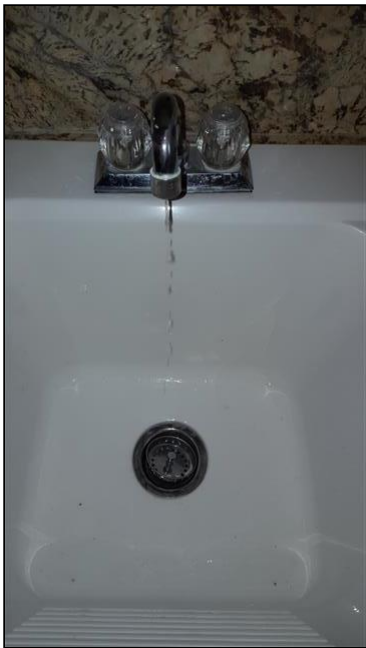
13.7 Item 2(Picture)

The laundry faucet has abnormally low water supply. Possible causes include, but not limited to, the faucet itself, supply valves and lines, or associated plumbing. Recommend evaluation and repair by a plumbing professional.

Corrosion is present at the laundry faucet supply valves. No leaking was observed at the time of inspection, however corrosion can be indicative of slow leaking and can lead to sudden failure in the future. Recommend proactive repair of corroded plumbing and valves by a plumbing professional, or careful monitoring.

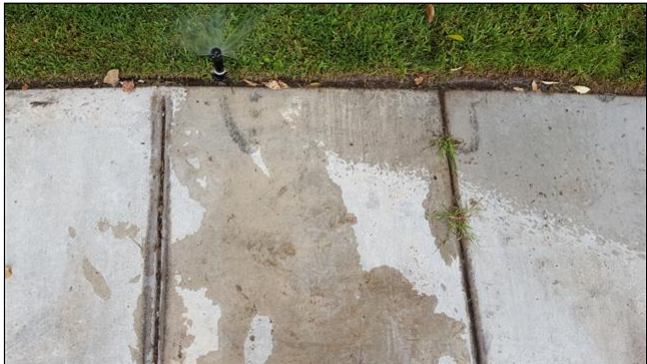
14.1 Item 1(Picture)

The sprinklers were operated via manual cycle with the control box at the exterior. Timed function, flow, and adequacy was not assessed. Excessive amounts of water is present during operation of the pop ups primarily at the front possibly from poorly functioning pop ups or supply leaks. Recommend system maintenance, repair, and optimization be performed by a landscape professional.

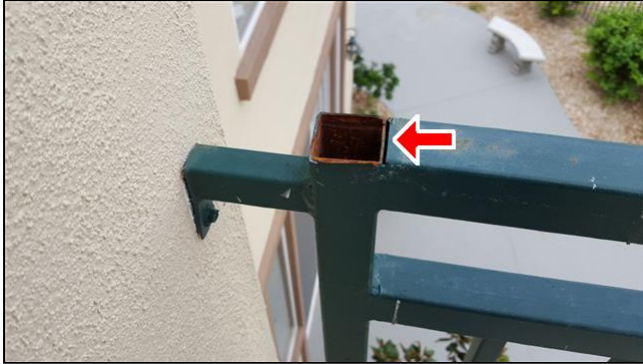
3.4 Item 1(Picture)

(2) The balcony railing is missing post caps which can expose sharp edges which can be a hazard. Recommend replacement of missing caps by a qualified professional.

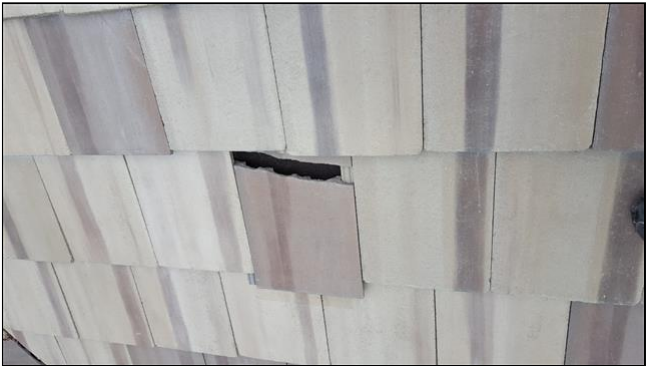
4.2 Item 1(Picture) rear

(2) Areas of tile recommend for repair include an area of broken and cracked tile with underlayment exposed primarily at the the east side, at least one broken tile at the front, and a broken edge tile at the rear. Recommend repair of all broken and dislocated tile according to standards by a roofing professional.

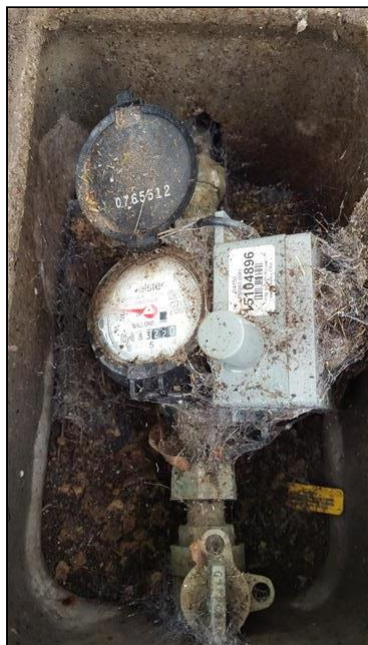
The photos show your shut off device at the buildings exterior and water meter box. The meter was not moving indicating that a leak in the supply lines is not present. While this does not guarantee that no leaks do or will exist it is the best that can be provided during a visual inspection.

5.2 Item 1(Picture)
Informational photo of water
meter and shut off at curb.

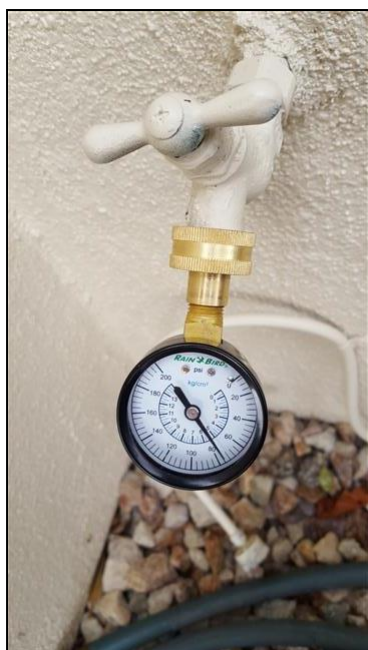
5.3 Item 1(Picture)
Informational photo

No defects were observed for the water supply piping to the main as identified in the Styles & Materials section. Water pressure recorded at the exterior main was (75) PSI. See Photo.

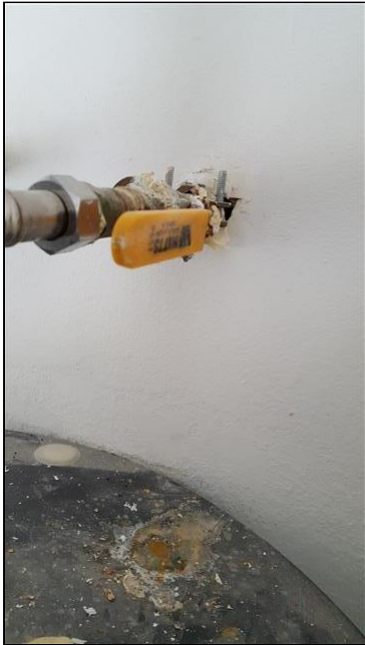
5.7 Item 3(Picture)

(2) Corrosion is present at the water heater plumbing. No leaking was observed at the time of inspection, however corrosion can be indicative of slow leaking and can lead to sudden failure in the future. Recommend proactive repair of corroded plumbing and valves by a plumbing professional, or careful monitoring.

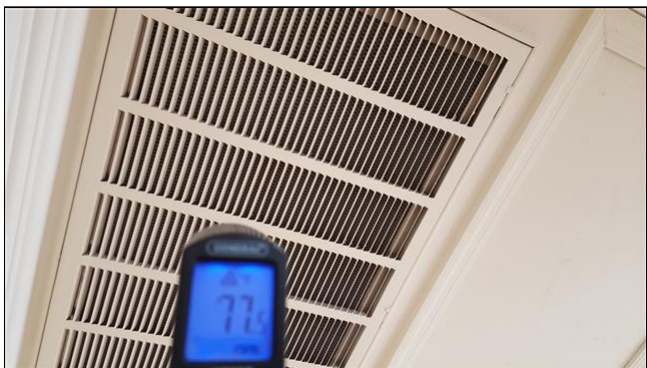
7.5 Item 4(Picture) Upstairs return

(2) An air temperature differential test was performed on the upstairs main house unit to determine if the difference in temperatures of the supply and return air are between 16 degrees F and 23 degrees F, which indicates that the unit is cooling as intended. The supply air temperature on the upstairs system read (79 degrees F), and the return air temperature was (77 degrees F). This indicates that the upstairs unit's range in temperature drop is less than normal. Recommend evaluation and repair by an HVAC professional.

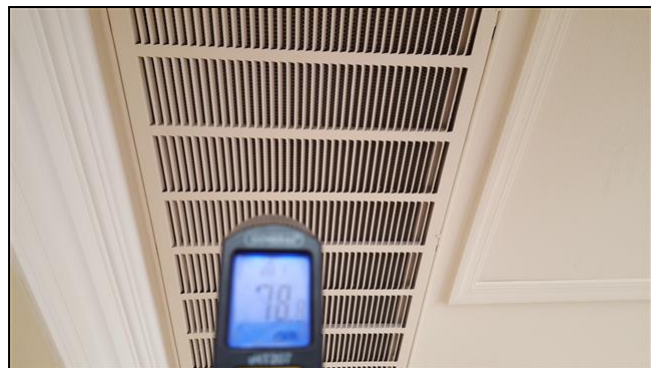
7.5 Item 5(Picture) Downstairs return

(3) An air temperature differential test was performed on the downstairs main house unit to determine if the difference in temperatures of the supply and return air are between 16 degrees F and 23 degrees F, which indicates that the unit is cooling as intended. The supply air temperature on the downstairs system read (58 degrees F), and the return air temperature was (78 degrees F). This indicates that the downstairs unit's range in temperature drop is normal.

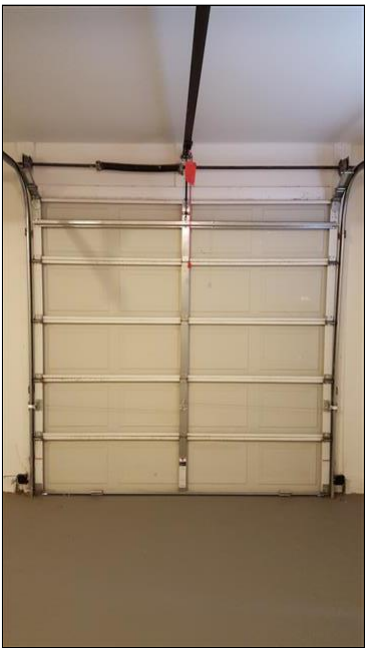
9.2 Item 2(Picture)

- (1) The garage overhead door has a safety pressure/tension reversing mechanism that was tested and found to be operating properly. This feature should be verified periodically in accordance with the garage door opener's homeowners manual. Additionally, this door is equipped with a safety light beam sensors which reverses the door when the light beam gets crossed. This feature was observed to be operating properly. This is deemed to be a positive finding.
- (2) The west garage door has minor damage and is not smoothly operable. Recommend maintenance, adjustment, and repair as necessary by a garage door professional to restore proper operability.

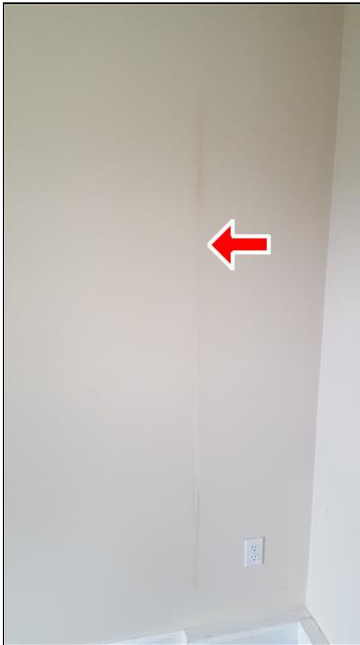
10.3 Item 1(Picture) casita

(1) Cracks are present at the casita walls and ceilings. The areas tested dry by thermal image at the time of inspection. Recommend repair to match existing finish.

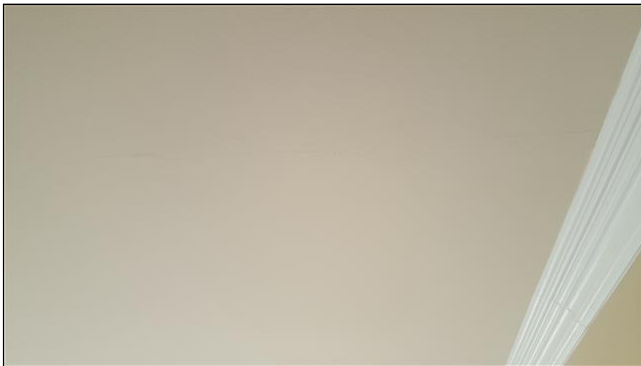
10.3 Item 3(Picture) master bedroom, representative photo

(2) Minor cracks are evident in the walls and/or ceilings, and evidence of possible prior or current water intrusion. Recommend evaluation and repair of roof as detailed in 4.2(2) and continued monitoring and repair if further defects become apparent. Recommend repair to drywall defects to match existing finish as desired.

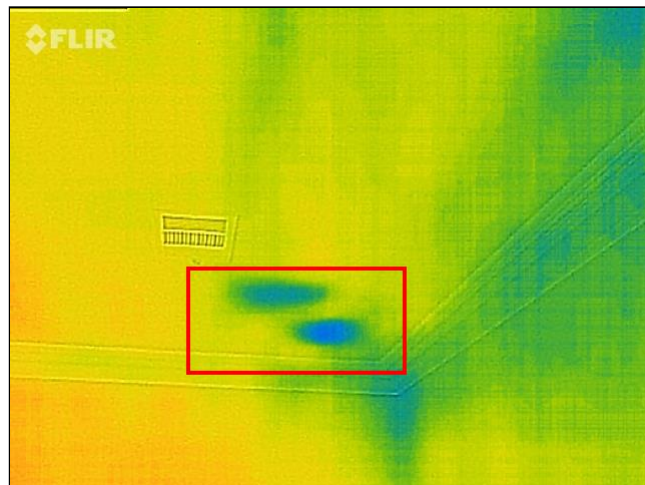
10.3 Item 5(Picture) master ceiling

(3) The master bedroom and upstairs ceilings were evaluated by thermal image in the area of the observed roofing defects. Multiple areas of apparent water intrusion were observed where indicated by thermal image at the east side of master bedroom ceiling and in the attic. Recommend evaluation of the roofing material including the underlayment in the areas noted by a licensed roofing professional and necessary repair to standards. Recommend repair to affected structure and wall finish by a qualified professional.

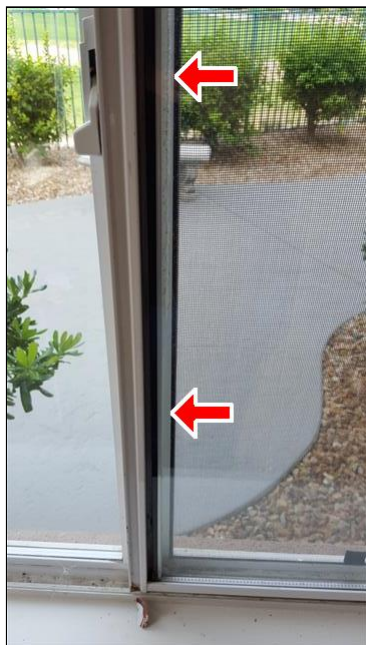
10.5 Item 3(Picture)

(3) The sliding window at the north facing living room window is missing a metal component of the frame which covers the edge of the glass pane. Recommend repair by a window professional to prevent losing of the glass pane.

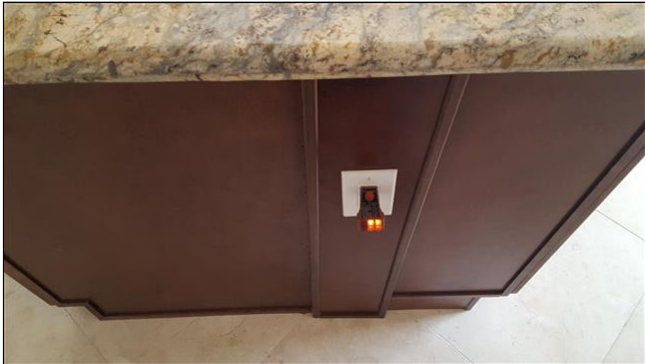
11.4 Item 1(Picture) island

The kitchen outlets at the island are not GFCI protected as required. Since the kitchen has been remodeled, all counter top outlets should be upgraded to GFCI protection according to current standards. Recommend installation of GFCI protection at the island and kitchen countertop outlets by an electrical professional.

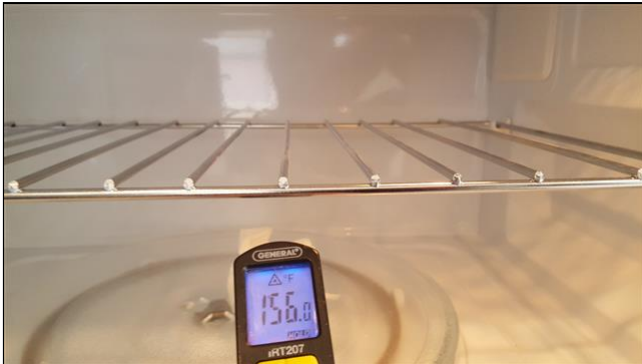
11.8 Item 1(Picture) Informational photo

The microwave oven, fan / light controls were tested and functioned as intended at time of inspection. Testing for leakage is not within the inspection scope.

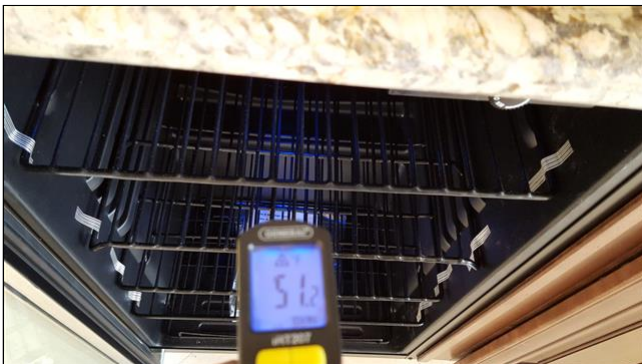
11.10 Item 1(Picture) Informational photo

(1) Bar refrigerator appears to be working properly at the time of inspection

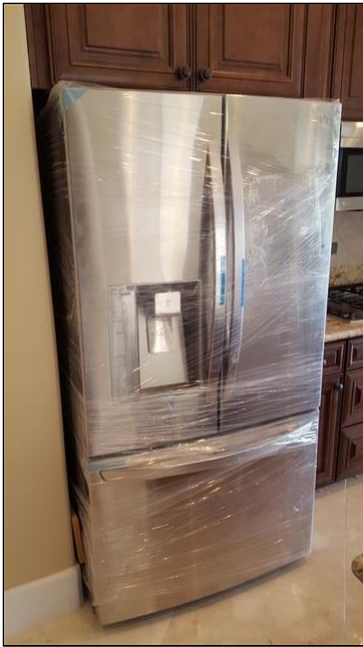
11.10 Item 2(Picture)

(2) Refrigerator is present but has not been installed, therefore was not evaluated during this inspection.

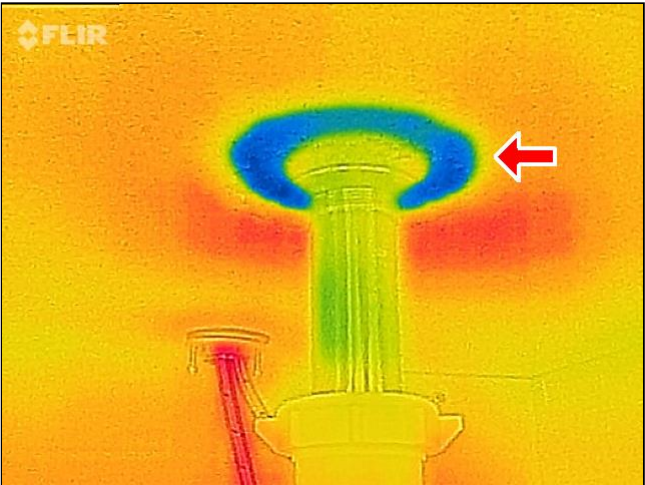
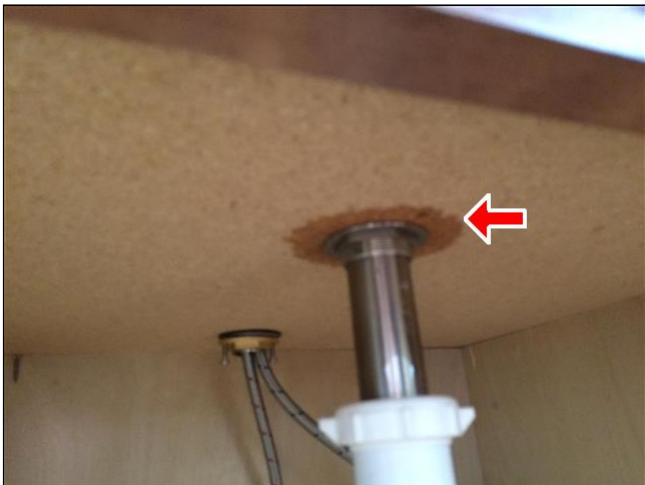
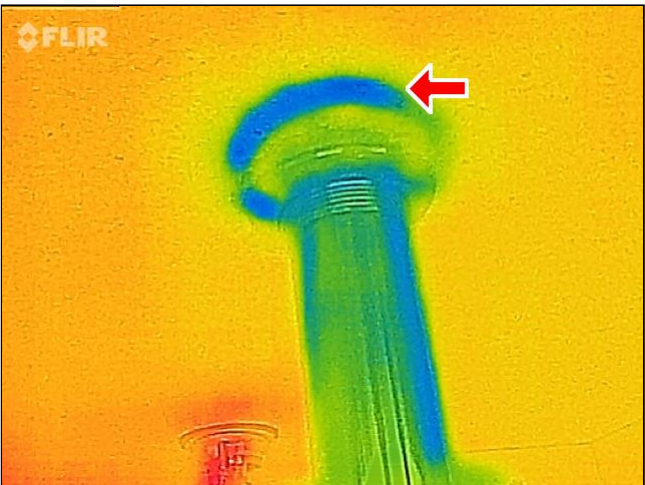
(2) The sinks at the master bathroom are leaking around the drain. Recommend repair by plumbing professional.

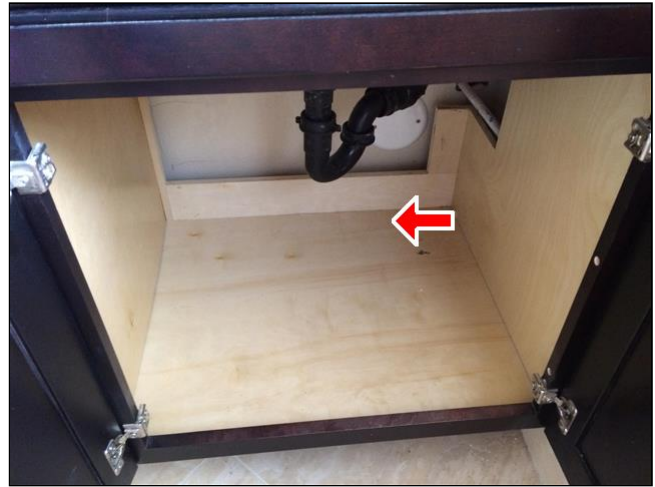
12.1 Item 8(Picture)

(3) Water is present at the casita sink where indicate from an apparent leak. Recommend evaluation and repair by a plumbing professional.

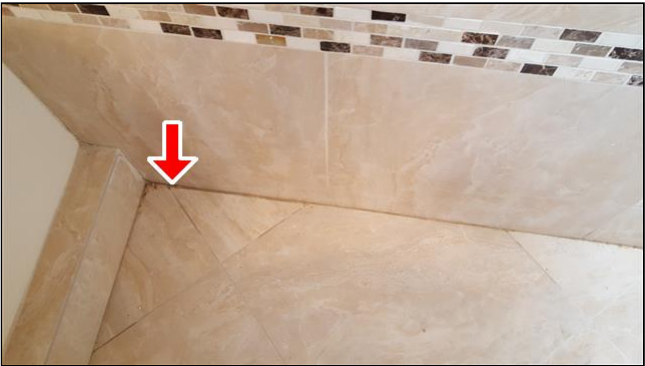
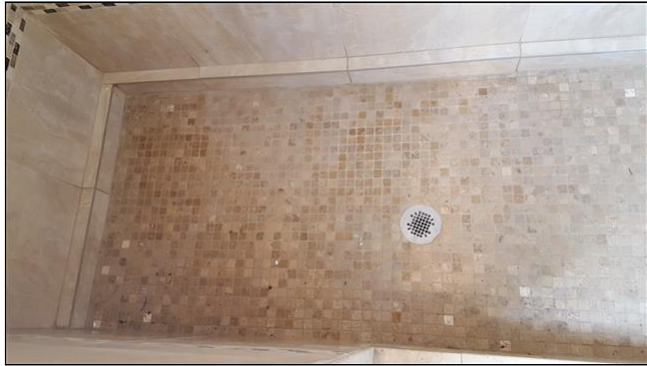
(1) Cracked grout at the casita shower is present. The shower accumulates water at the far end. After operating the shower, evidence of water intrusion is evident by thermal image outside the shower in the corner at the exterior bathroom wall. Recommend evaluation and necessary repair by a tile professional.

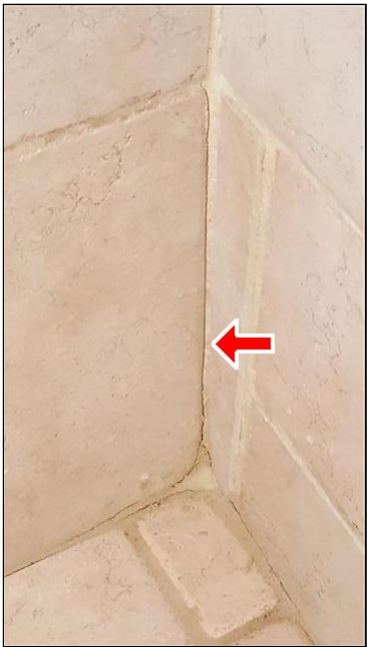
12.4 Item 6(Picture) master bathroom shower

(2) Grout at the master bathroom shower is deteriorated. Missing or deteriorated caulking and grout can promote water penetration into the adjoining structure. The old caulking and any loose grout should be removed and the openings resealed and regouted.

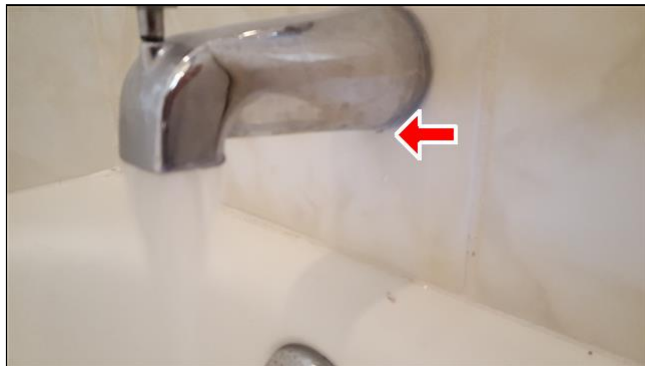
12.5 Item 1(Picture) upstairs guest bathroom

The tub/shower faucet at the upstairs guest bathroom leaks water at the wall and has a shower diverter not properly operable. After operating the faucet, evidence of water intrusion is present at the guest bedroom wall opposite the bathroom which indicates the faucet could be leaking water into the wall. Recommend evaluation and repair or replacement of the faucet by a plumbing professional. Since the possibility of persistent water intrusion into structure is present, we recommend a mold inspection by a licensed mold inspection company.

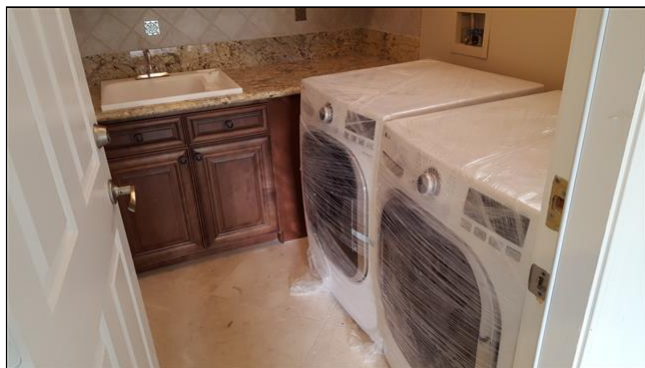
13.3 Item 1(Picture) Informational photo of laundry area

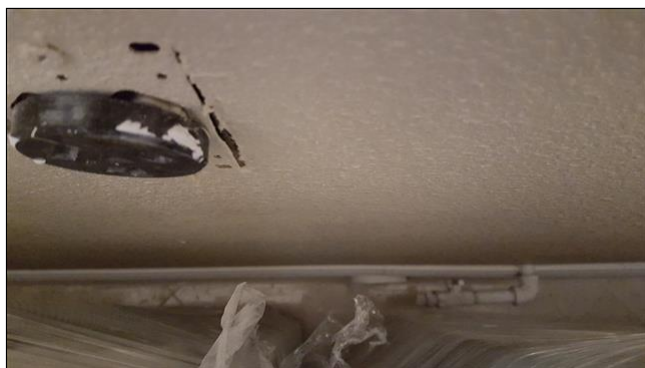
13.4 Item 1(Picture) Informational photo

The dryer vent line piping has been inspected where visible and accessible. Vents and connections within walls and other inaccessible areas cannot be inspected. The dryer vent should be kept clear of lint and other debris to ensure proper function. A vent clogged with debris or lint will decrease the efficiency of the dryer, and may be considered a potential fire hazard. The building should never be left unoccupied when the dryer is in use.

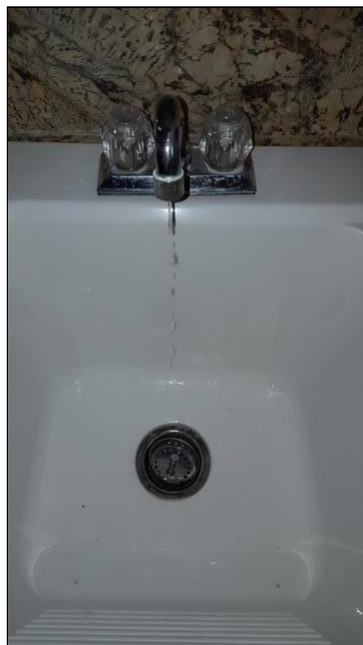
13.7 Item 2(Picture)

The laundry faucet has abnormally low water supply. Possible causes include, but not limited to, the faucet itself, supply valves and lines, or associated plumbing. Recommend evaluation and repair by a plumbing professional.

Corrosion is present at the laundry faucet supply valves. No leaking was observed at the time of inspection, however corrosion can be indicative of slow leaking and can lead to sudden failure in the future. Recommend proactive repair of corroded plumbing and valves by a plumbing professional, or careful monitoring.

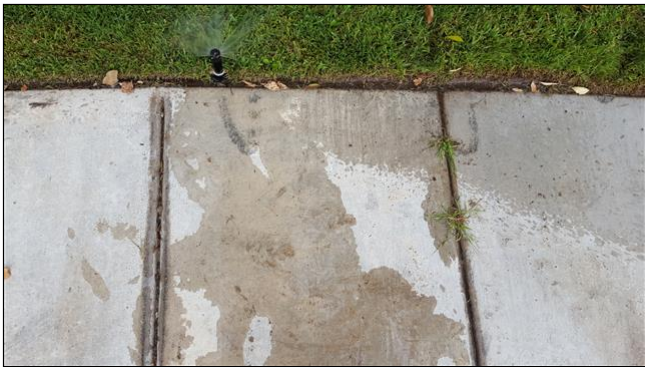
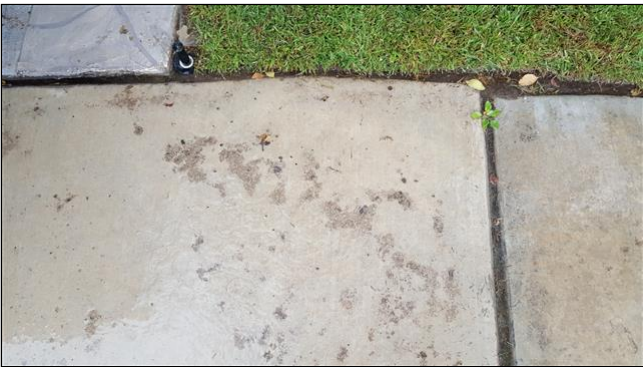
The sprinklers were operated via manual cycle with the control box at the exterior. Timed function, flow, and adequacy was not assessed. Excessive amounts of water is present during operation of the pop ups primarily at the front possibly from poorly functioning pop ups or supply leaks. Recommend system maintenance, repair, and optimization be performed by a landscape professional.
